**Trial of Global Positioning
System Based Field
Wreckage Plotting and
Analysis Equipment Using
Data from a USMC F/A-18
Aircraft Accident**

DSTO-TR-0828

**Airframes and Engines Division
Aeronautical and Maritime Research Laboratory**

On August 20, 1998 a United States Marine Corps F/A-18 aircraft crashed at Delamere bombing range in the Northern Territory. AMRL was invited to aid in the investigation by trialing the AMRL wreckage mapping and analysis equipment at the site. The equipment was used to plot and record all wreckage of interest. Maps of the wreckage were produced on site and handed over to the accident investigation team. These rapidly produced maps, along with the experience brought with the AMRL investigators with on site wreckage examination, greatly aided the accident investigation team to expedite recovery of the site and clarify many aspects of the accident. To this end, the trial of the equipment was very successful. Following this trial, the data was used to explore the capabilities of other visualisation software, and its relevance to accident investigation. The results of this are presented during the discussion of the accident.

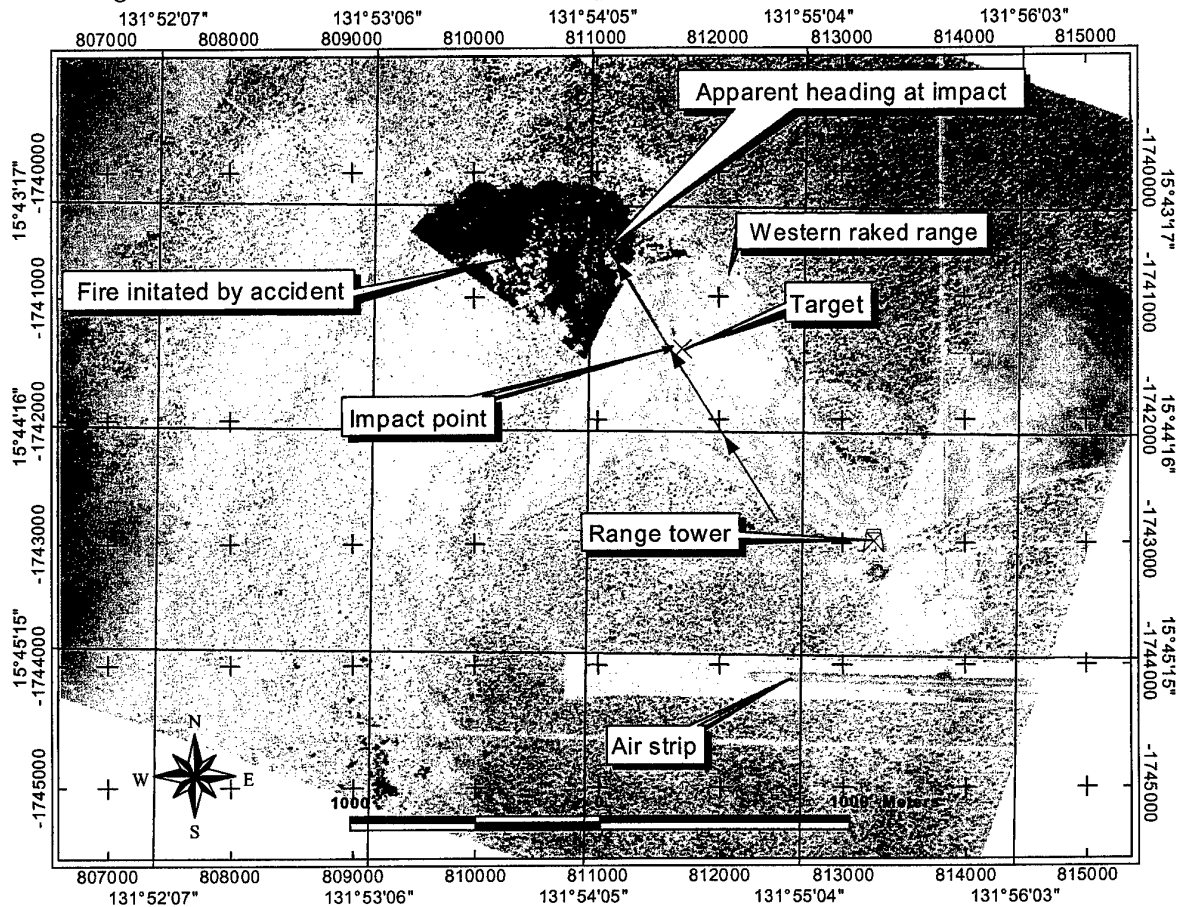
Initial mapping consisted of tracing the extent of the impact crater, the dirt ejected from the crater and the position of the target. The general site layout is shown in Figure 4. This was

Figure 4. A map of the site shows the main points of interest.

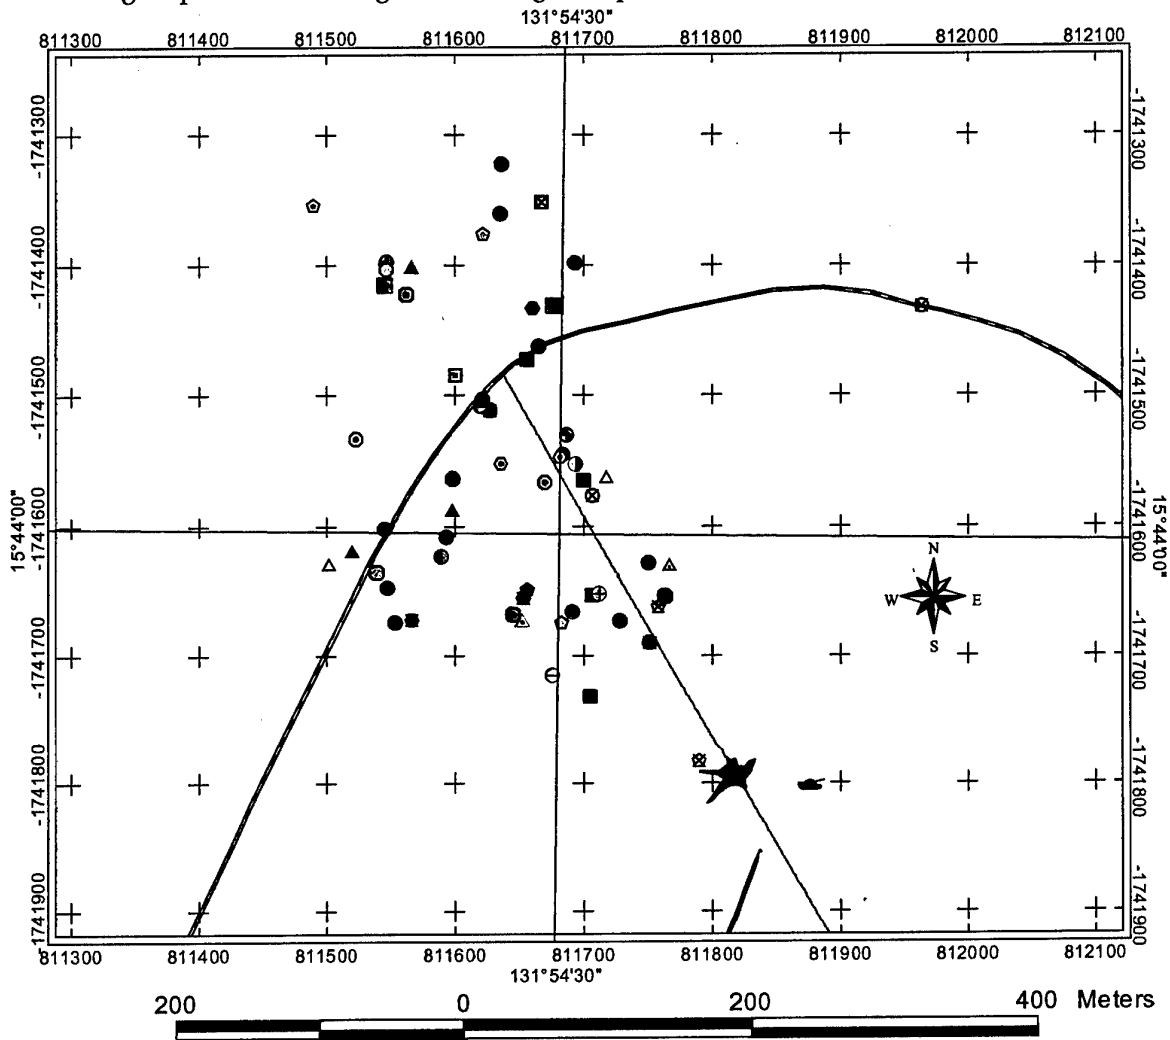
An examination of numerous engine parts in the field found that most of the turbine blades were stripped, as expected if the engines were under power at impact. Most pieces of discs had rotational scoring and several other failures were consistent with engine rotation under power.

Engine parts with the legend showing each part identified

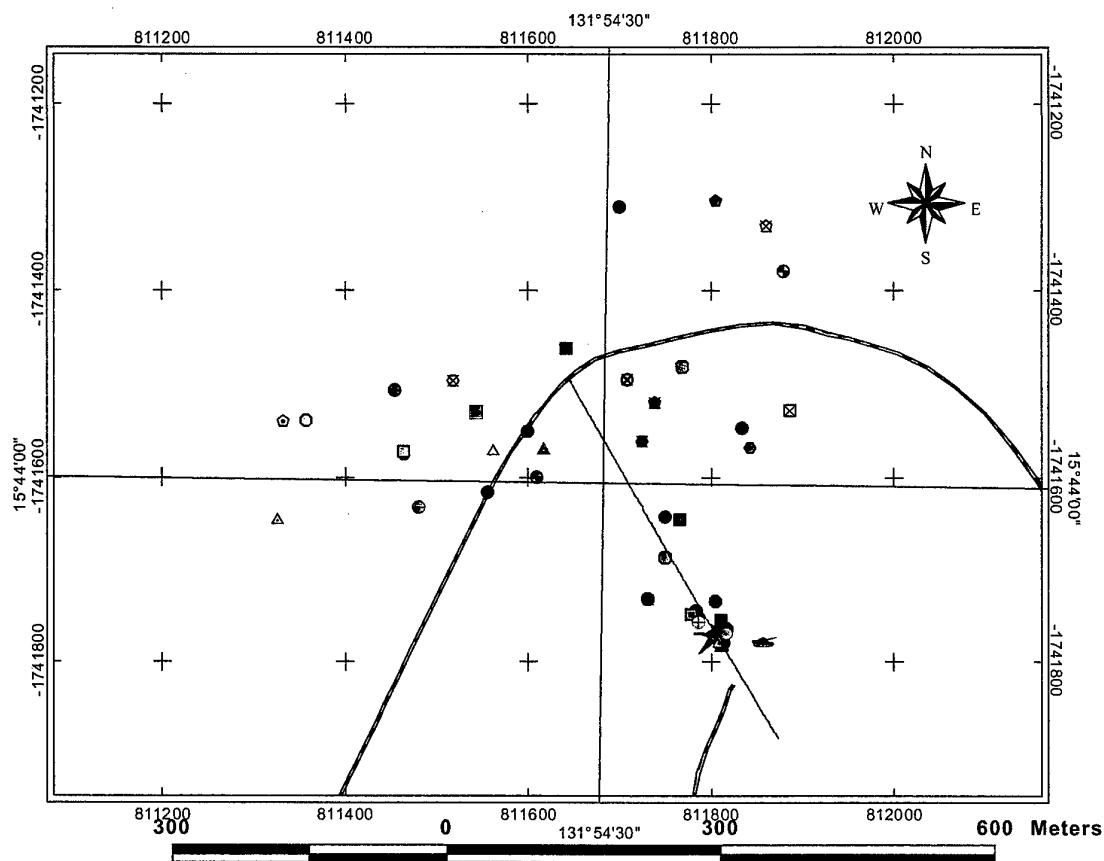
Armament parts. In this case the legend has each part identified

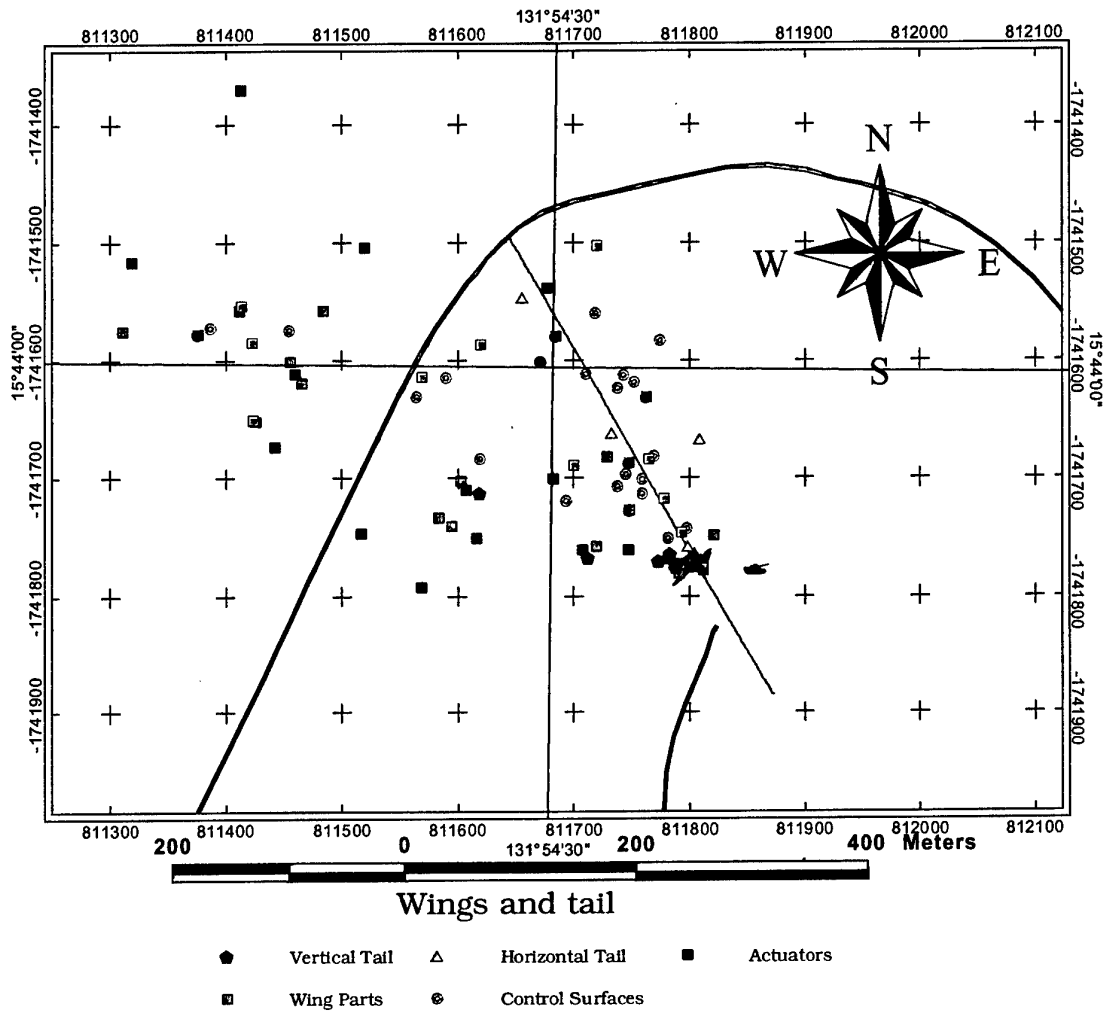
Aerodynamic surfaces and associated parts showing their trend to the north west of the aircraft line of travel.
